CONTRAST Project Manager Report Aircraft payload

CONTRAST GV payload

11/22/2013

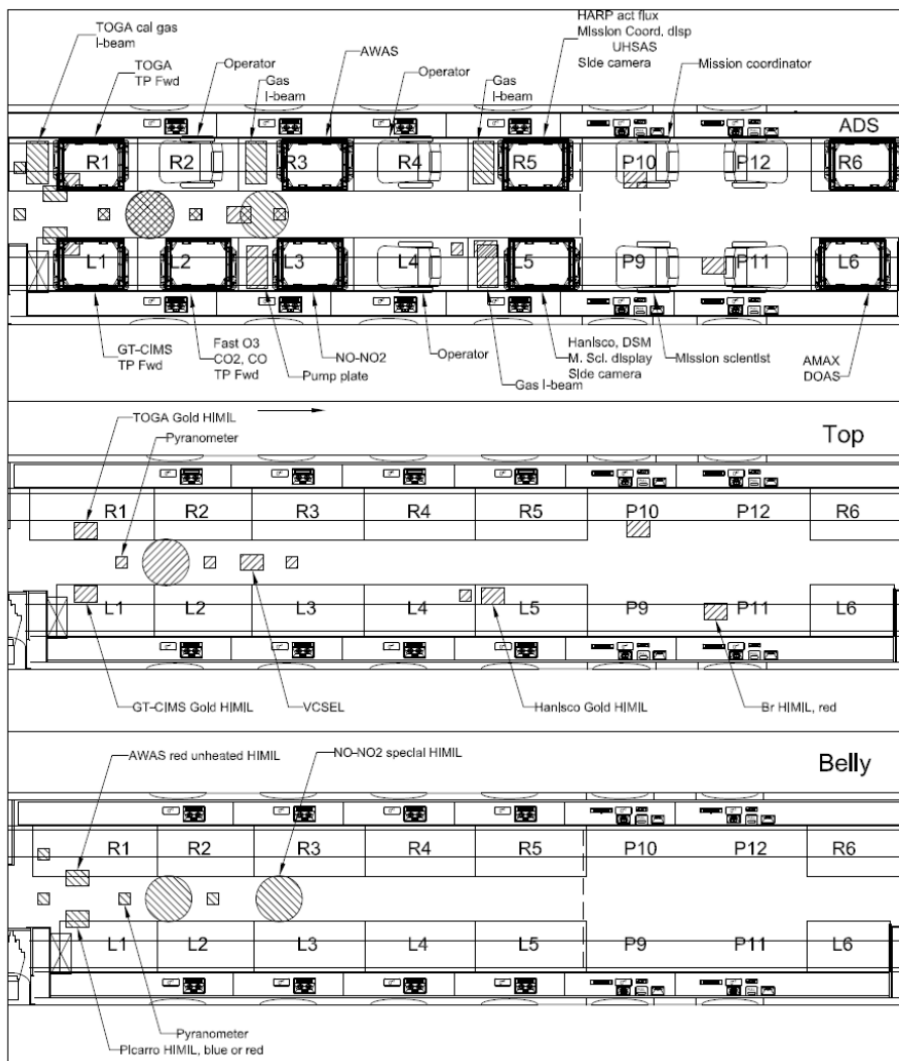
- VCSEL
- Fast O3
- NO-NO2
- VUV CO
- Picarro CO2,
- CH4
- CH2O
- GT-CIMS
- AMAX-DOAS
- Br (BRIGHT)
- AWAS
- TOGA
- UHSAS
- 2D-C
- CDP
- HARP
- Mission coord.
- Mission sci.
- Gas cylinder rack
- Gas I-beam, x4
