SPICULE (2021) Project Manager Report

Lawson, DeMott, Heymsfield

I. Aircraft Payload and Layout

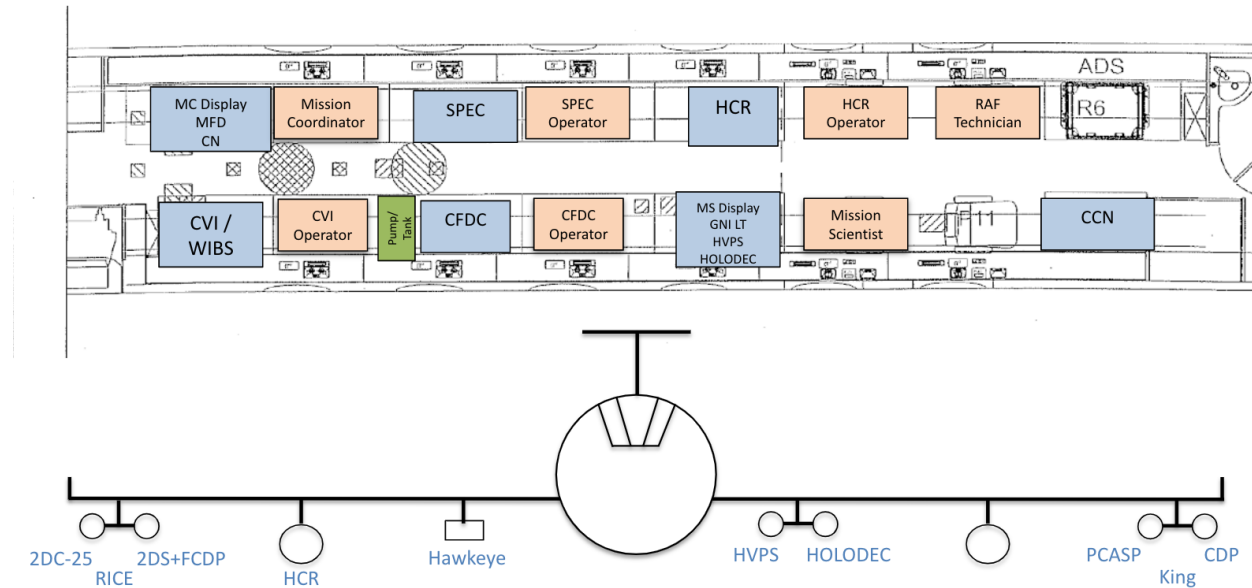
Apertures: CVI (L1 Bottom), CFDC (L1 Top), VCSEL (R1 Bottom),
 CN (R1 top), GNI (Aft Bottom Viewport), CCN (P11 top)
 Cameras: Forward
